Re: 501 Pond Street, Ashland "Parcel B-1" Resource Area Status

501 Pond Street, Ashland Field Photographs, July 6, 2021

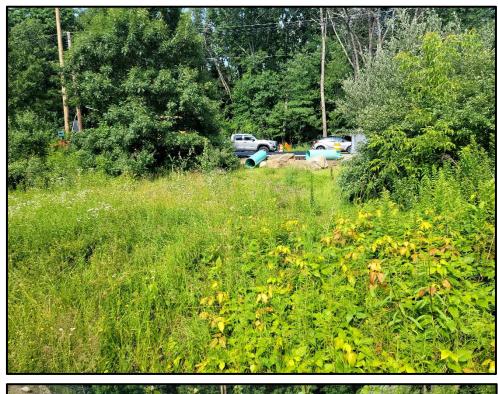
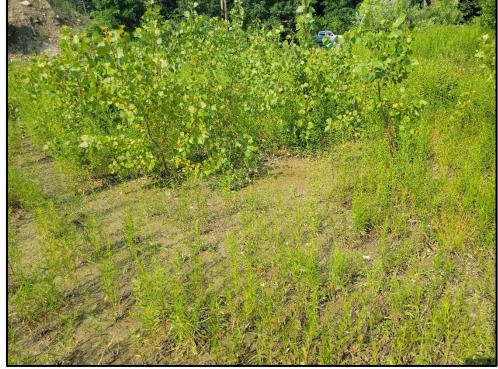
Top and bottom: Views to the east showing compacted mineral soil with aspens, goldenrods and autumn olives.

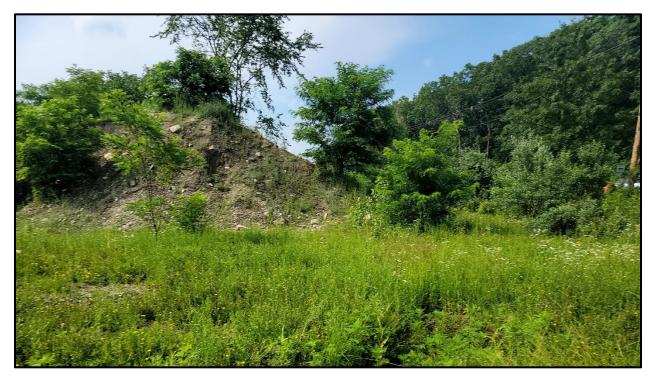
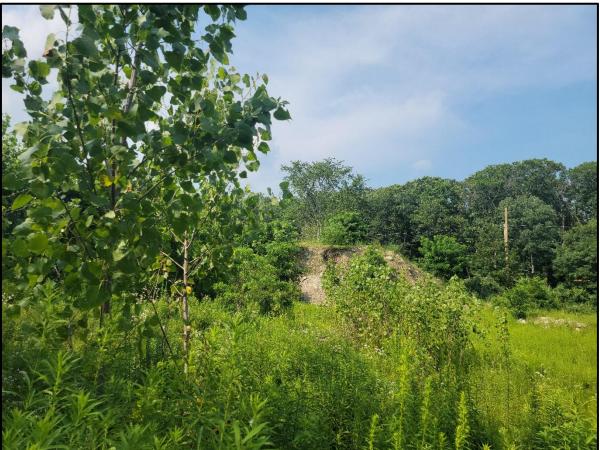
Top and bottom: Non-native topography due to tailings piles displaced to the site ca. 2015 for construction to the north.

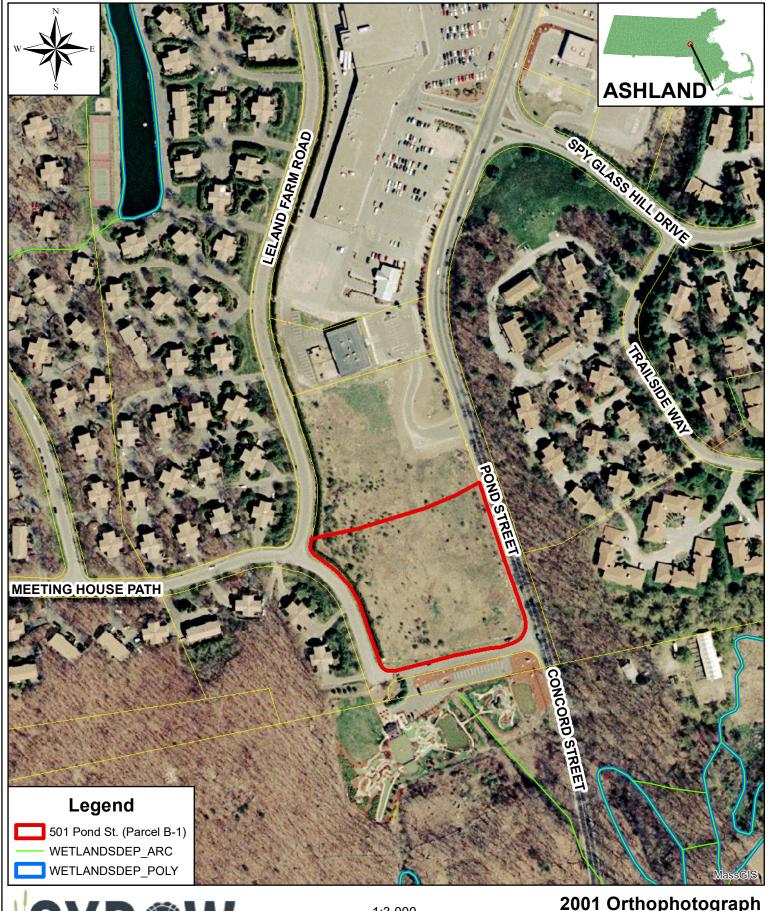
2001 Orthophotograph 501 Pond Street Ashland, MA

By 2001 development on the north parcels had commenced; the subject parcel was still fallow field. The spring of 2001 was particularly wet in eastern Massachusetts and that imagery is useful in demonstrating ephemeral surface waters. 2008 imagery shows the field on 501 Pond Street succeeding to scrub-shrub habitat but otherwise unchanged. It appears that during the improvements to Parcel B-2 to the immediate north during the past decade Parcel B-1 was used as a staging and spoils material storage area; the exogenous material currently on the property is probably derived from foundation excavations to on Parcel B-2.

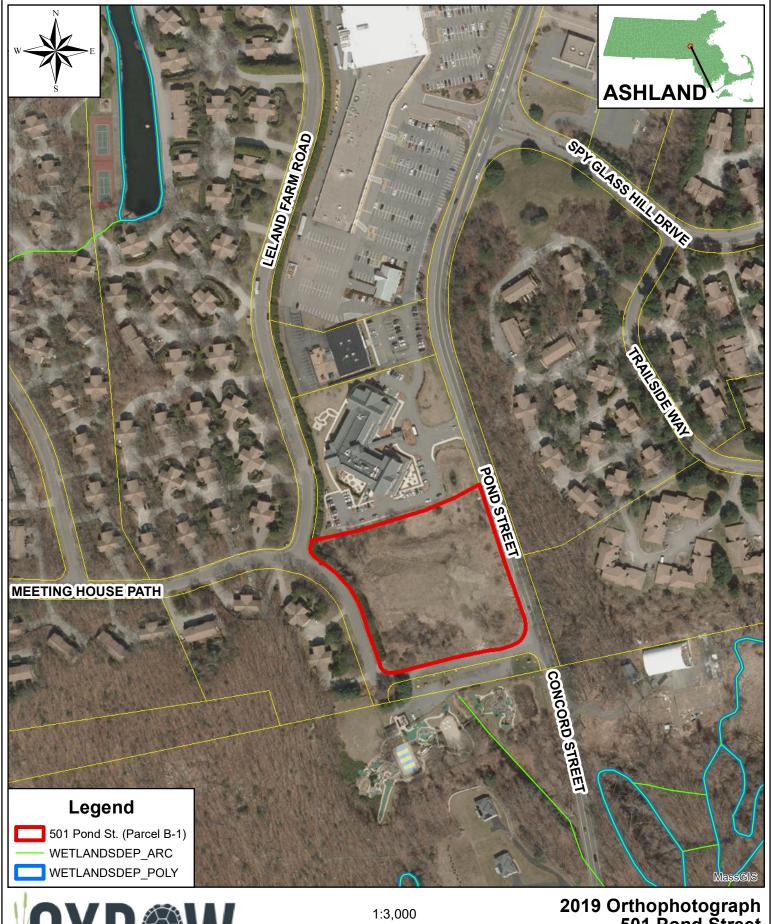
2019 Orthophotograph 501 Pond Street Ashland, MA

The current status of Parcel B-1 is typical of a recently disturbed and abandoned site in eastern Massachusetts. The soils are at least in part exogenous and compacted. The topography is altered due to the importation of soil, and the prevailing vegetation is largely exotic herbaceous and shrub species. Invasive species of prevalence include autumn olive, western ragweed, mugwort, Oriental bittersweet, purple loosestrife, daisy fleabane, among others. Native species include bigtooth aspen saplings and several goldenrods.
